Vehicle Collision Experts (VECO Experts)

Post Repair Inspections and Other Repair Issues

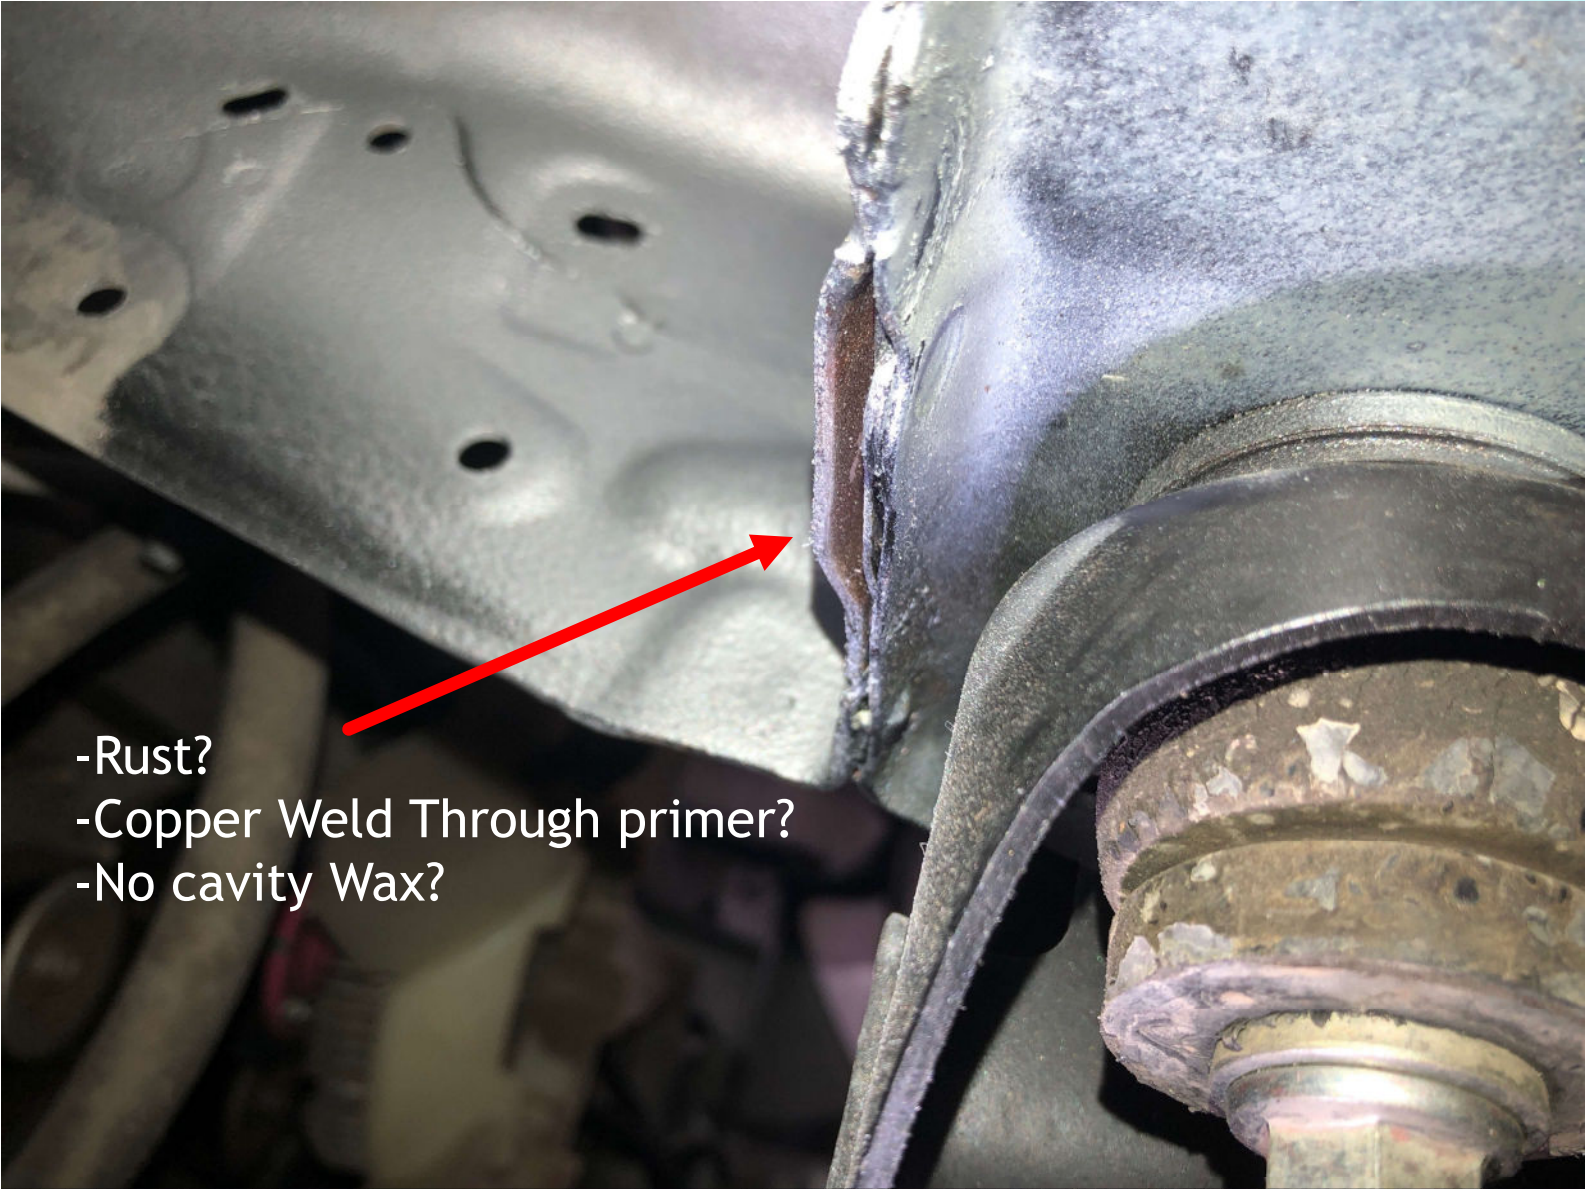
- Rust?
- Copper Weld Through primer?
- No cavity Wax?

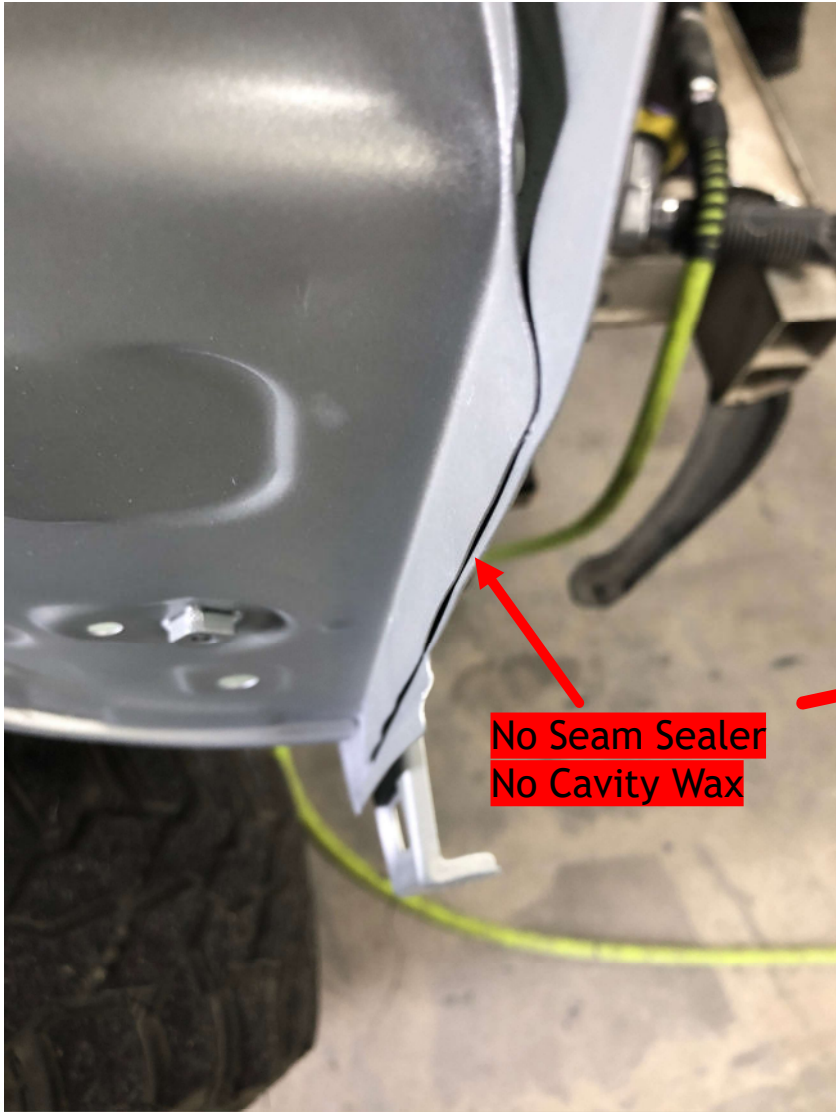
No Seam Sealer
No Cavity Wax

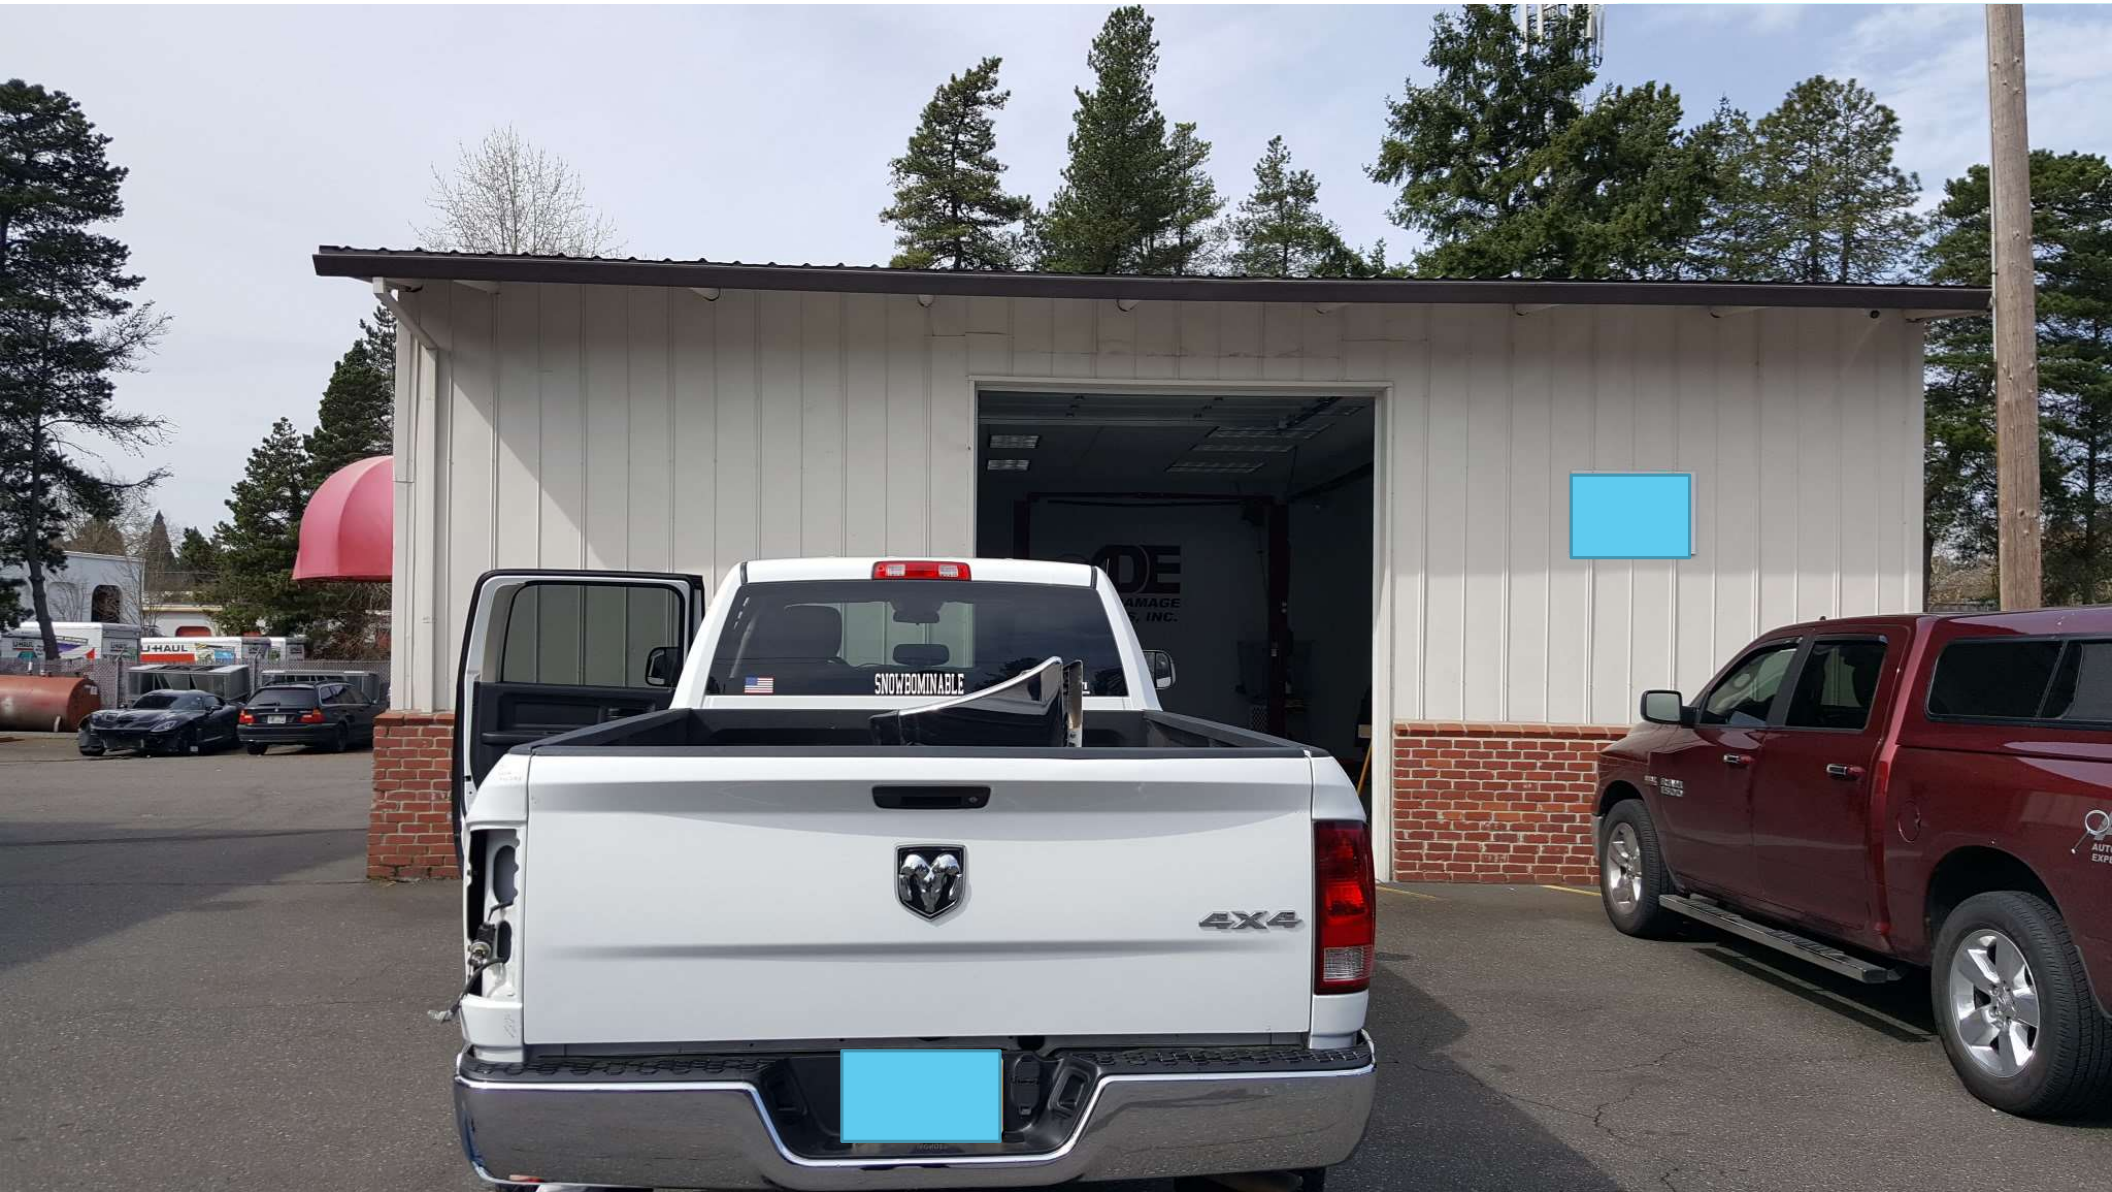
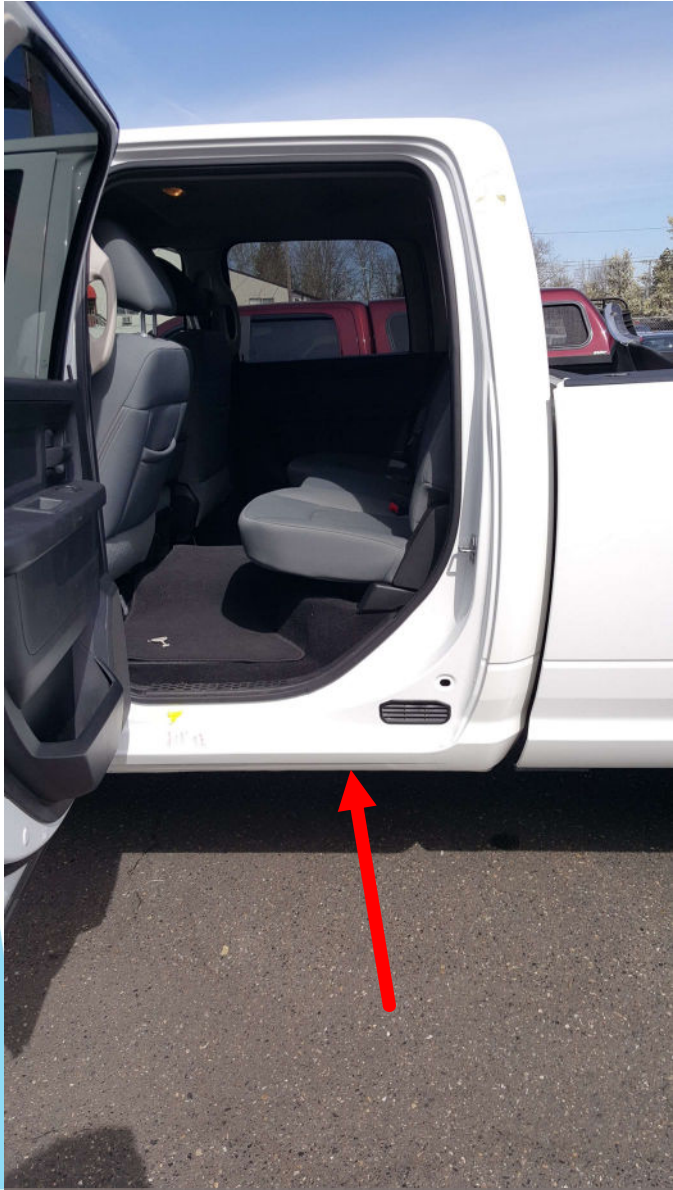
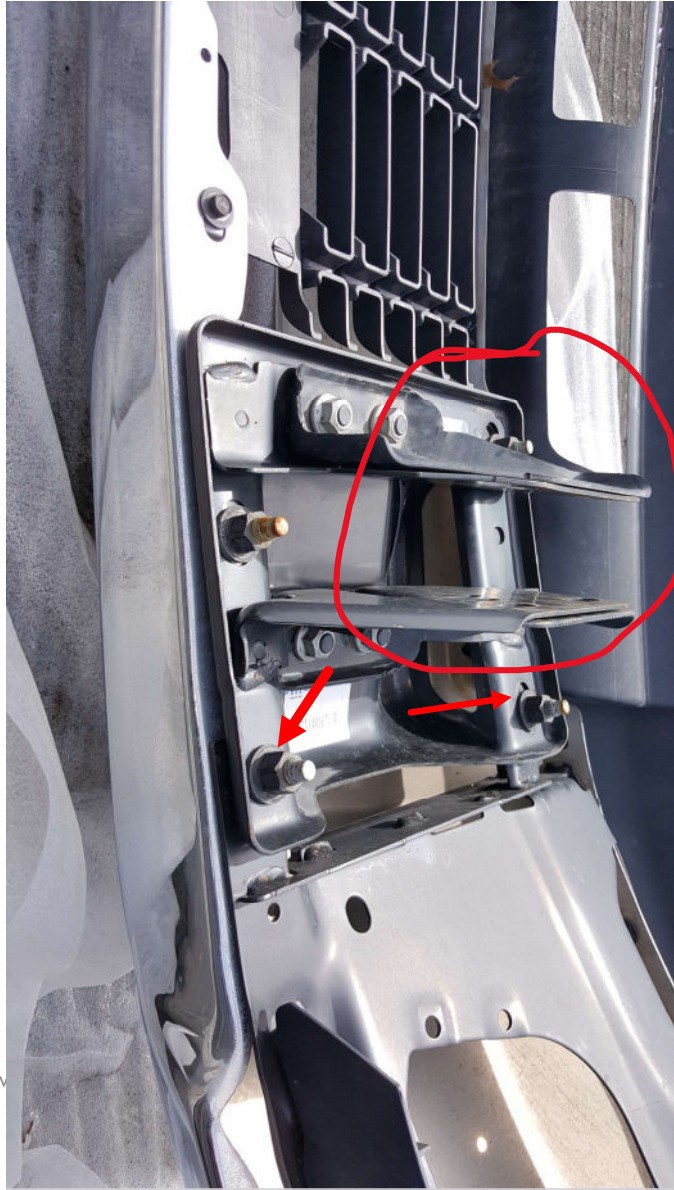
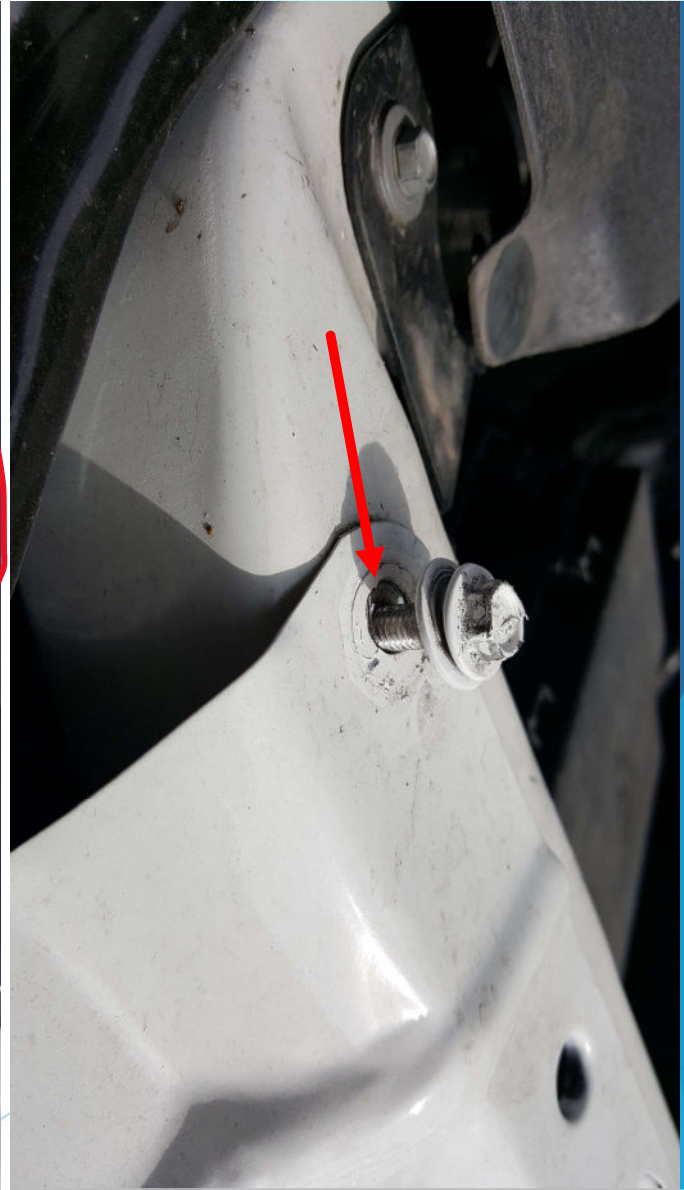
- Bumper brackets bent to fit bent frame
- Core support moved to compensate for bent frame
- Sheet metal maxed out to compensate for bent frame
- Rocker panel required a replacement due to not following OEM
- Frame twisted and listed to replace frame
- Vibration issue never addressed
- **Vehicle declared a total loss.**

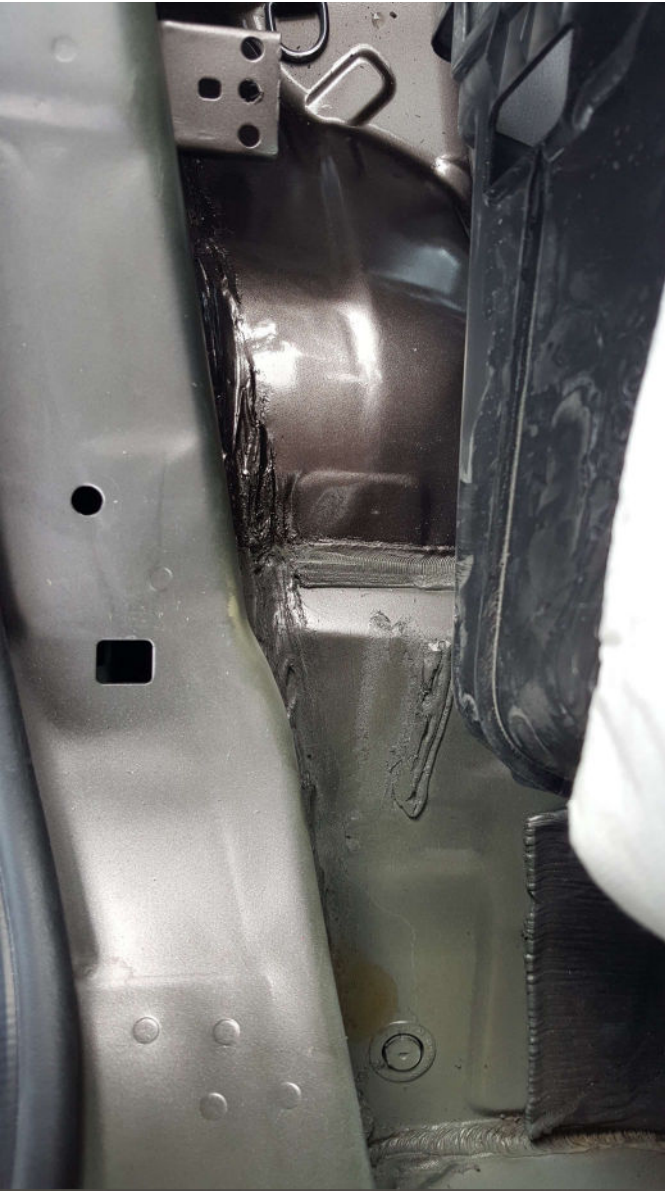
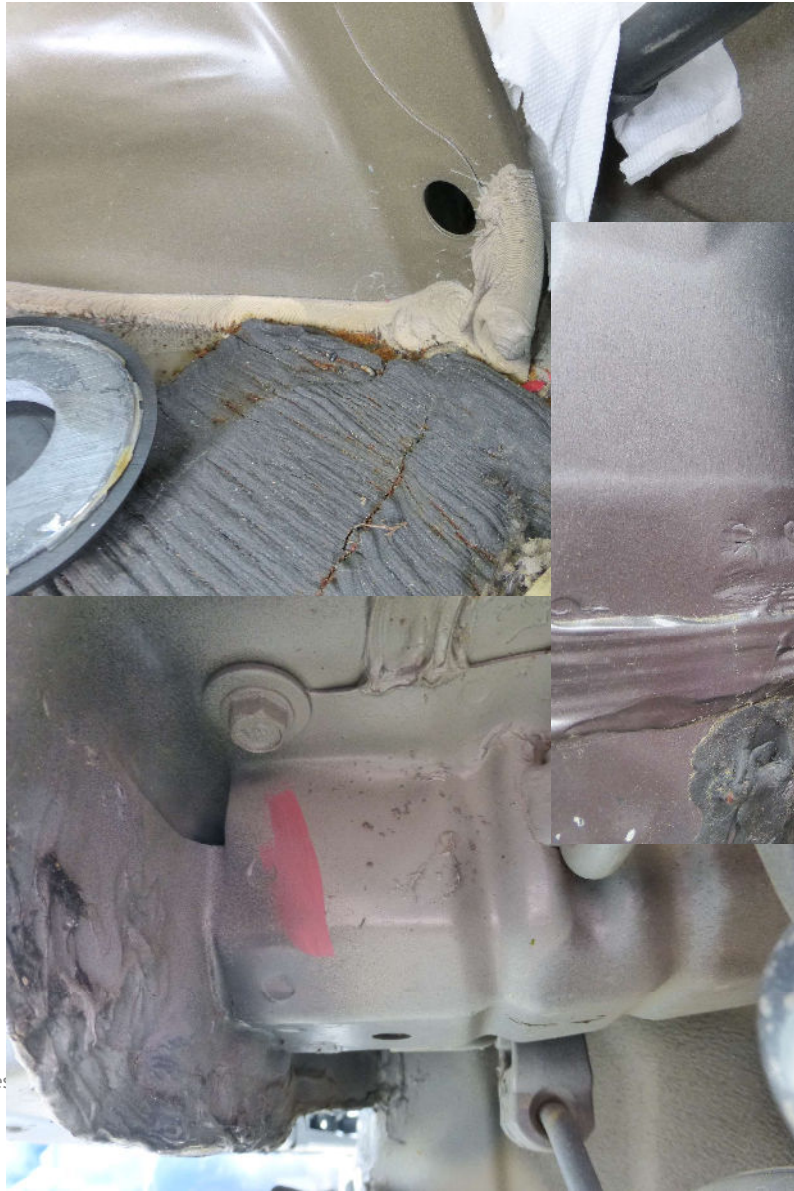
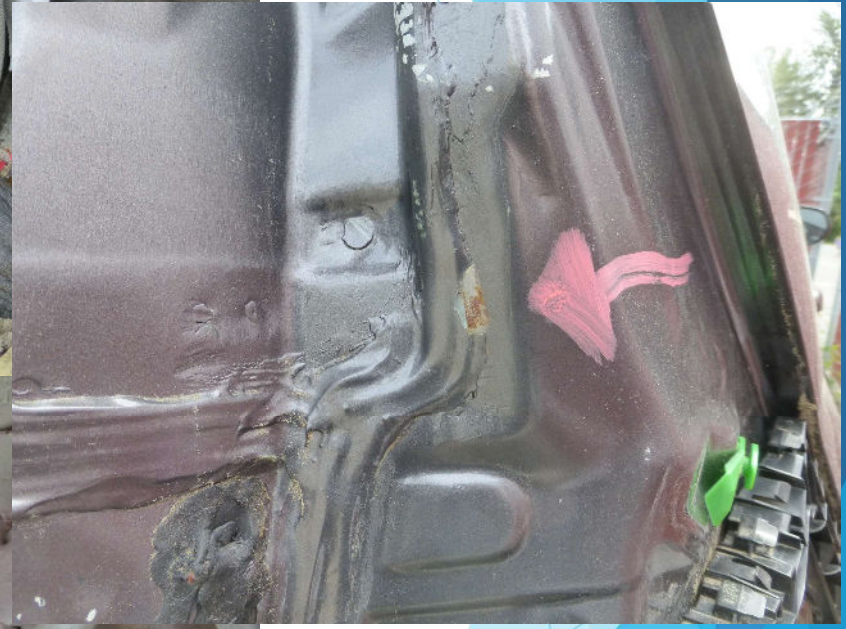
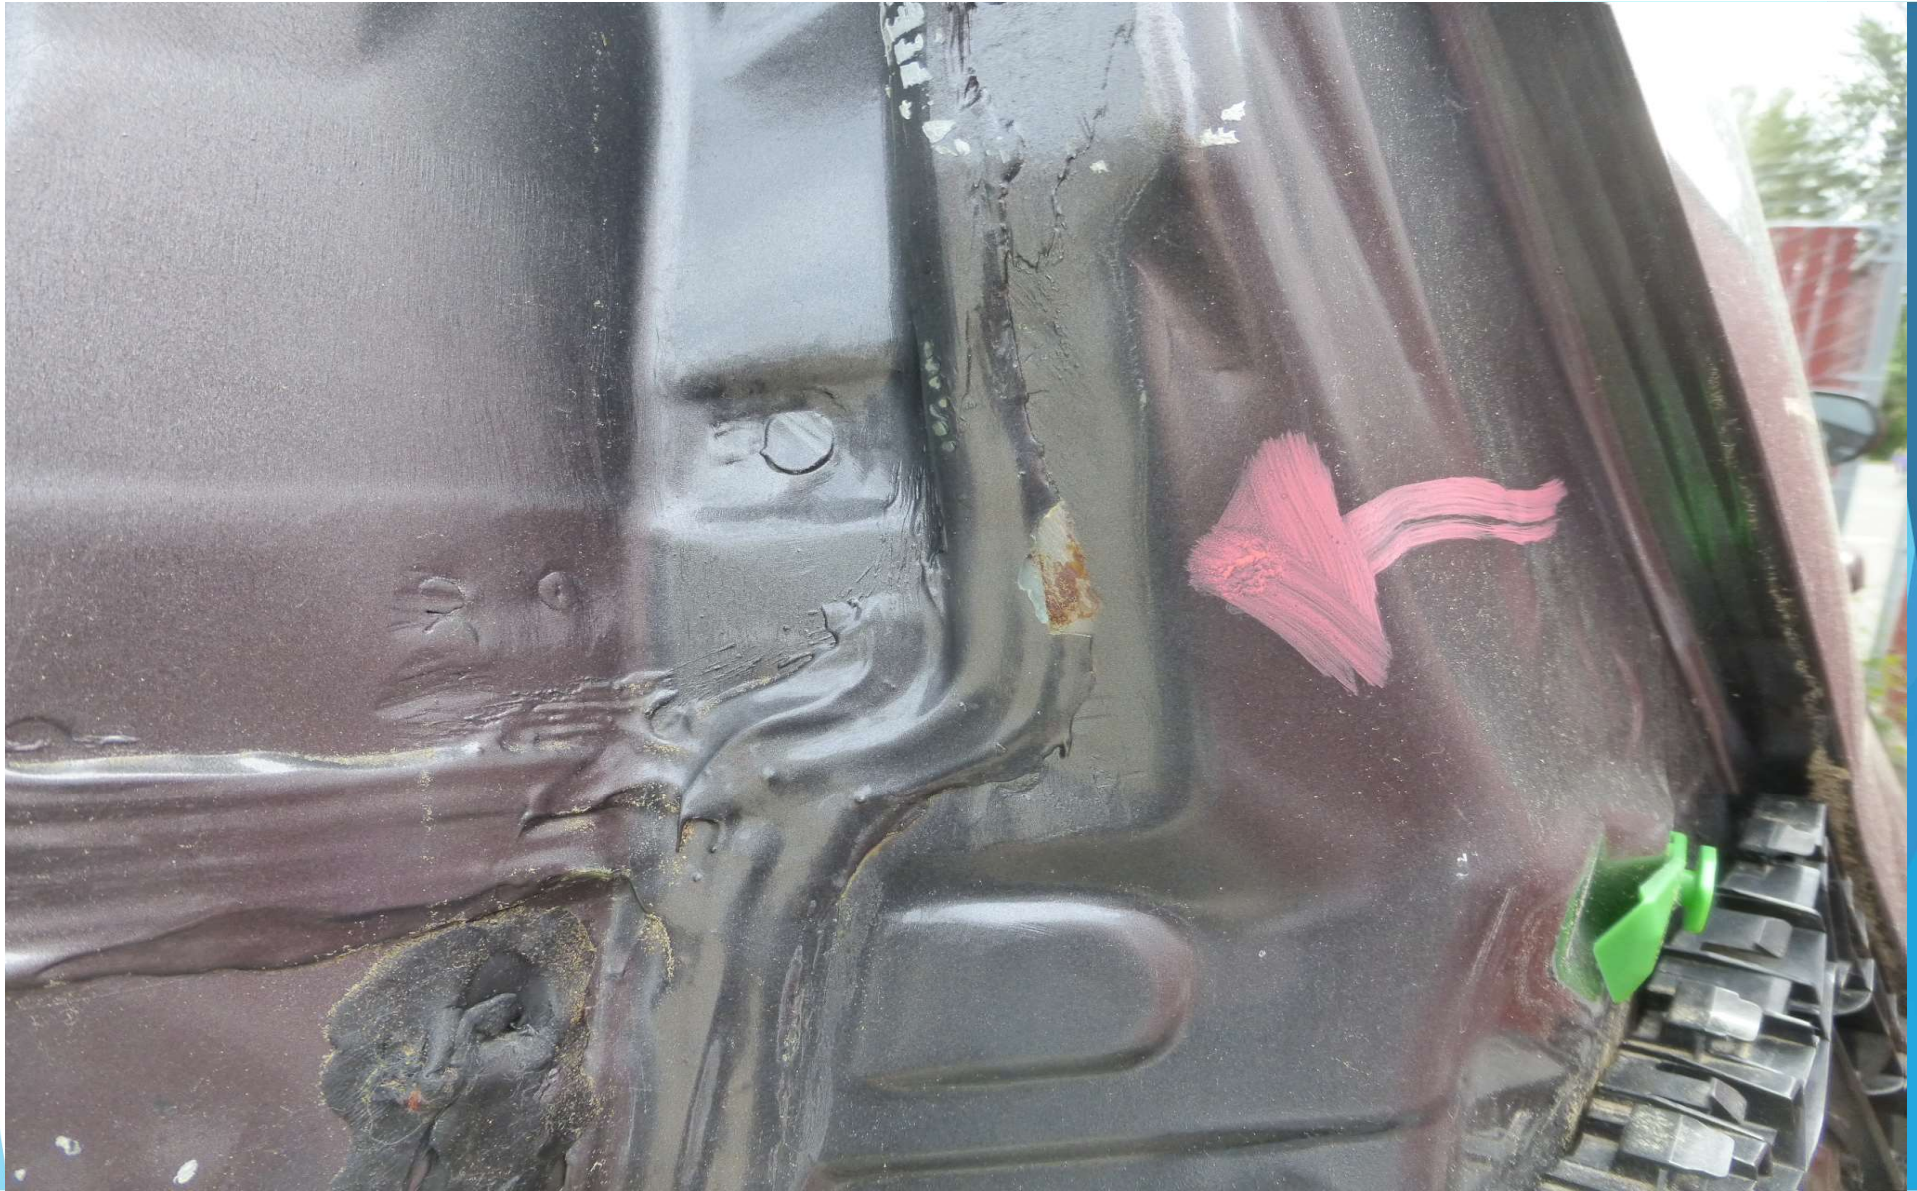
- Shop said vehicle was properly repaired now.
- Shop created a monster, customer found more stuff
- Shop did a re-repair
- Customer found more stuff
- Shop did re-repair.
- Customer gave up and started bad mouthing shop on Google, Yelp Etc....
- Rains came and customer noticed trunk was full of water.
- Taken to a water leak shop and taken apart
- Seam sealer leaking - water in between seams - complete structural re-repair.

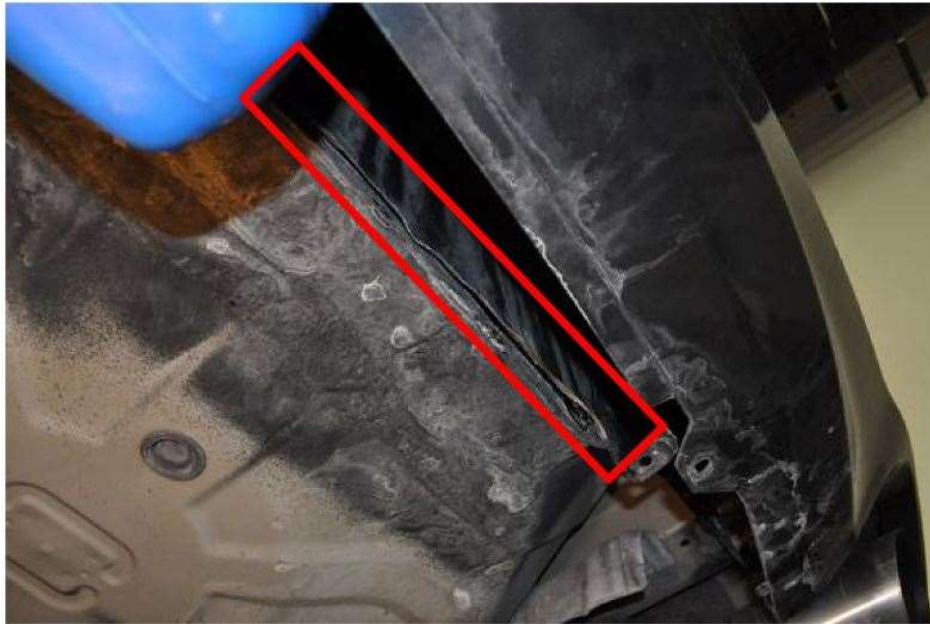
Rear body panel, with seam sealer removed.
Indications of rear body panel to trunk floor
mating flange separation (red box).

- *The evidence showed that repairs to the rear body panel were not performed in a workmanlike manner because: (1) they were not performed according to the manufacturer's specifications because structural bonding adhesive was used where not approved by the manufacturer, Nissan, (2) the welds were extremely poor, not in locations prescribed by Nissan, and the wrong types of welds, and (3) improper corrosion protection was applied.*
- *The evidence showed that repairs to the trunk floor were not performed in a workmanlike manner because: (1) sprayable seam sealer was used instead of brushable, pumpable seam sealer, and (3) the seam sealer was not refinished.*
- *The evidence showed that the repairs were all around sloppy work.*
- *The evidence showed that sloppy, shoddy, and improper repairs to the rear body panel made the vehicle unsafe to drive. (Minor formatting edits.)*
