Vehicle Collision Experts (VECO Experts)

Post Repair Inspections and Other Repair Issues

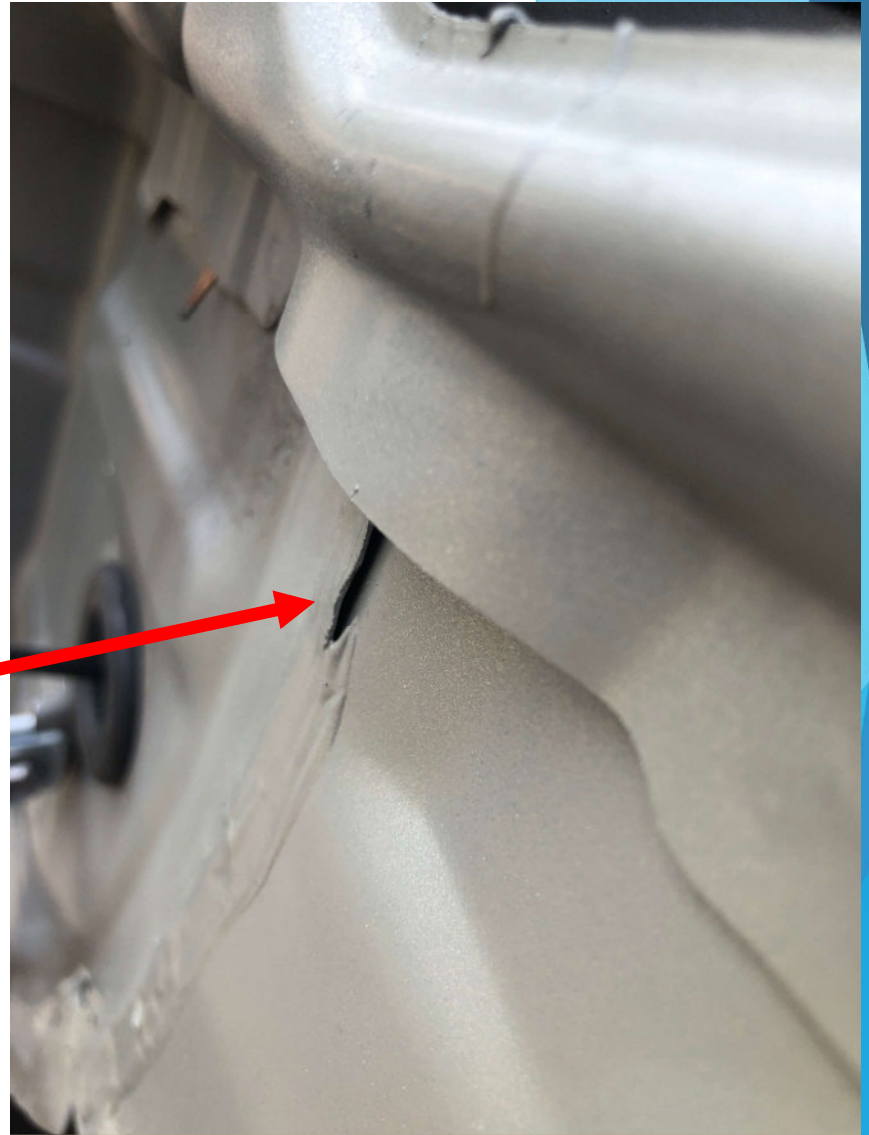
- Rust?
- Copper Weld Through primer?
- No cavity Wax?

No Seam Sealer
No Cavity Wax
